Situation and Task

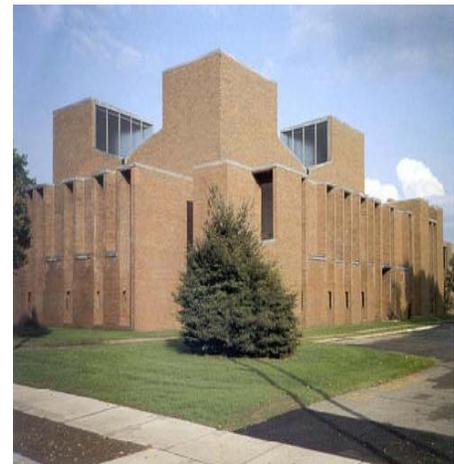
The cantilevered flat plates at the four corners had cracked and sagged over the years, some as much as 6 1/2" and thus required restoration. The cracking and sagging of the slabs also resulted in breakage of window panels and water entering the window system. Over the years, the Owner repaired the window system and revised the window head detail only to find that the slab movement would crack the windows again. A permanent solution was needed.

Ravi Engineering & Land Surveying (RE&LS) used the modern methods of Finite Element Analysis to analyze the flat plates and determine the cause for the cracking and sagging of the slabs. The analysis revealed that the slabs required bottom reinforcement even though the flat plates were cantilevered from two edges.

Restoring a roof structure of exposed concrete, block walls and light tunnels without compromising Louis Kahn's original design was no easy task. Addition of any structural members across the roof or columns in the sanctuary was completely out of the question. After careful consideration of several alternatives, RE&LS conceived and implemented an approach that would keep the profile of the retrofit to within a few inches of the bottom part of the slab.

The cracked slabs required support at the two cantilevered edges and needed bottom reinforcement to stabilize them. The design required a two step process. RE&LS designed a Vierendeel truss system to support the slab edges and used Carbon Fiber and E-Glass reinforcement, a composite strengthening system, to add the badly needed tensile strength to the bottom of the slab. Each Vierendeel truss was carefully designed with its vertical members matching the location of the new window mullions and preserving the original architectural rhythm.
